**SPECIAL ENGINEERING SERVICES TO
ESTABLISH INSPECTION CRITERIA FOR
BEARINGS TO IMPROVE LIFE PREDICTION**

FINAL ENGINEERING REPORT

SwRI Project 15-4012

Warner Robins Air Logistics Command
Directorate of Materiel Management
Robins Air Force Base, Georgia 31093

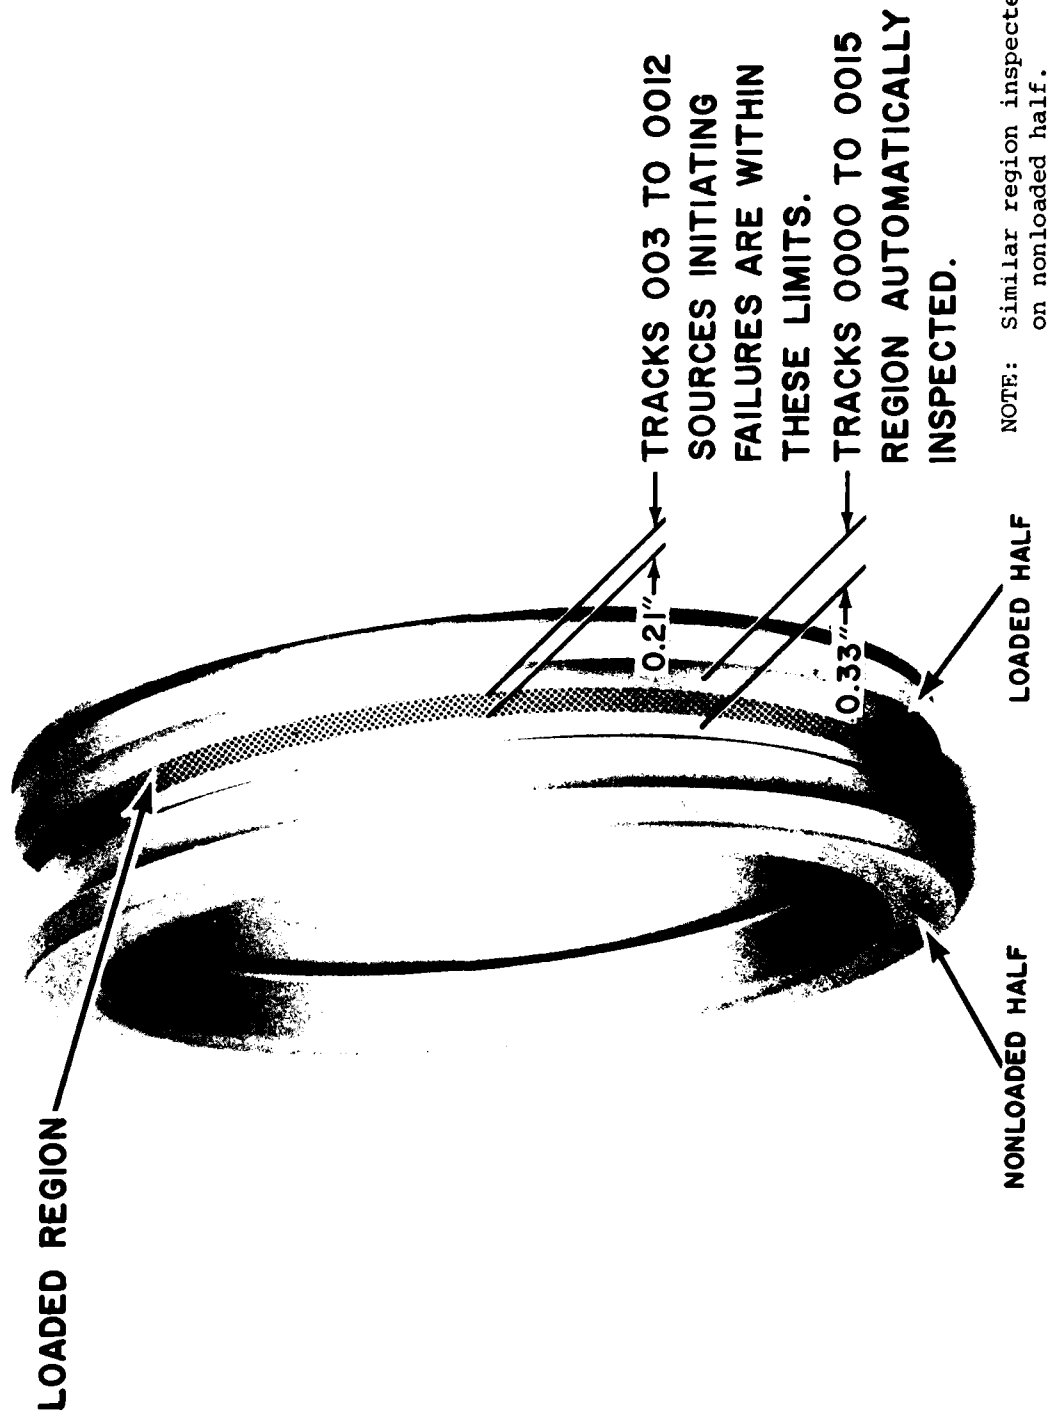
500 hours and for maximum Hertz stress values extending from 204 ksi to 332 ksi. Figures 10 and 11 illustrate the regions typically loaded on inner and outer races and the associated scan track inspection region as well as the track region in which the initiating failure sources occurred.

FIGURE 10. PHOTOGRAPH ILLUSTRATING RELATIONSHIP BETWEEN LOADED AND INSPECTED REGIONS ON AN INNER RACE.

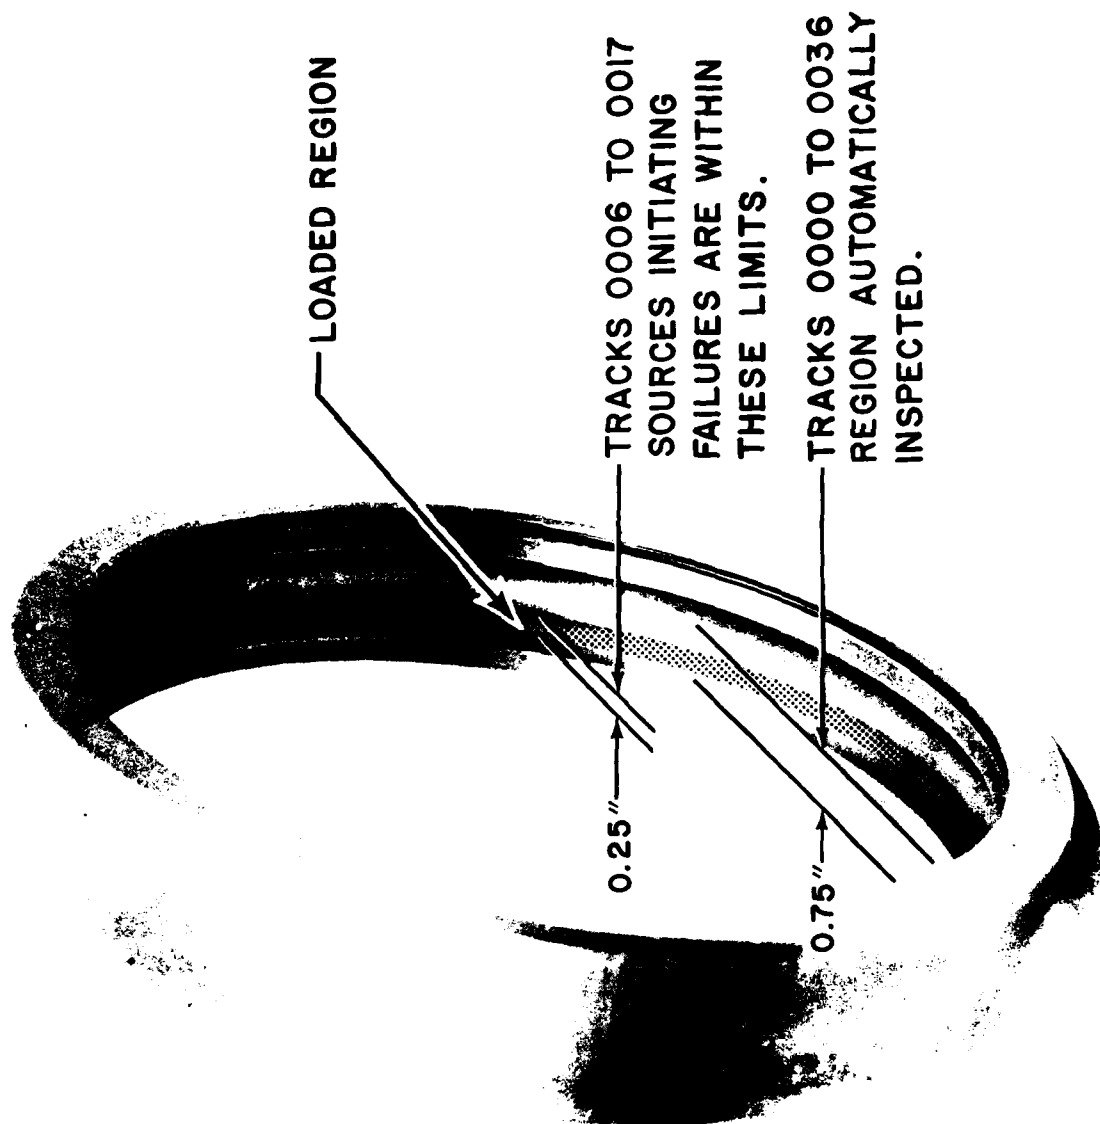
FIGURE 11. PHOTOGRAPH ILLUSTRATING RELATIONSHIP BETWEEN LOADED AND INSPECTED REGIONS ON AN OUTER RACE

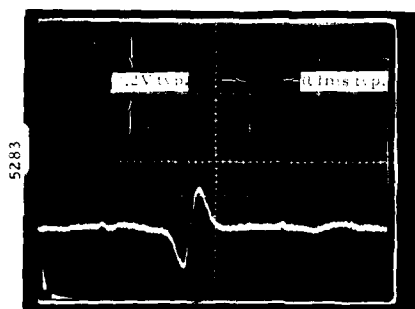
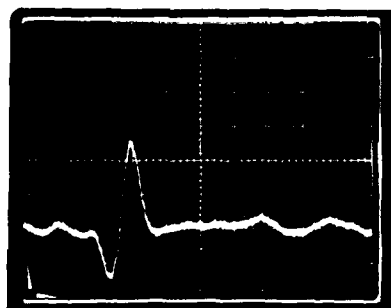
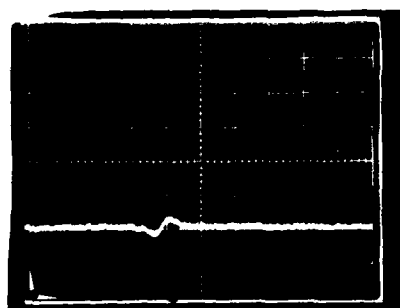
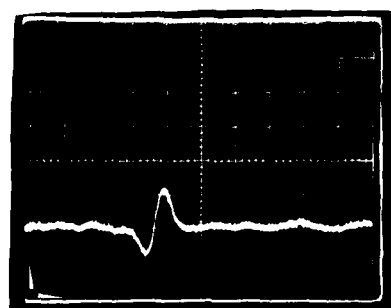
FIGURE 15. CIBLE RESULTS ON J57-#4 BEARING (S/N 219A-2)
 INNER RACE, NONLOADED HALF (S12052-1), 3761 HRS.
 SERVICE, VENDOR REWORKED.

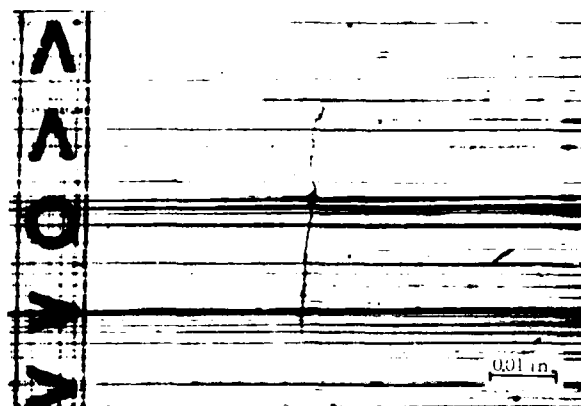
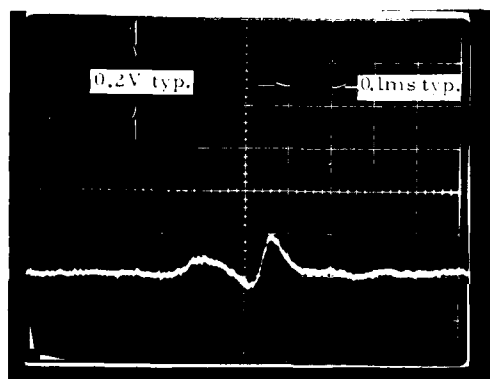
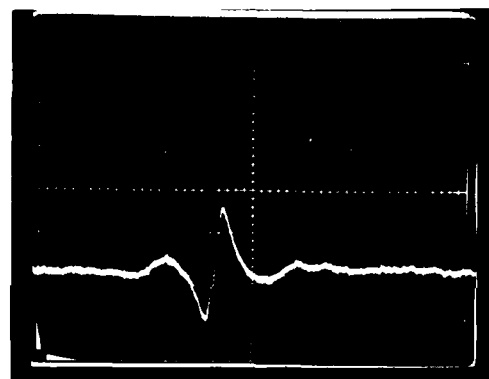
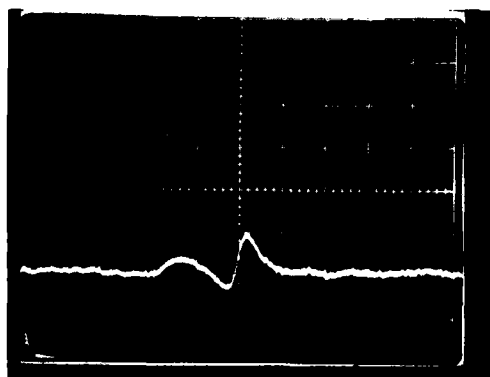
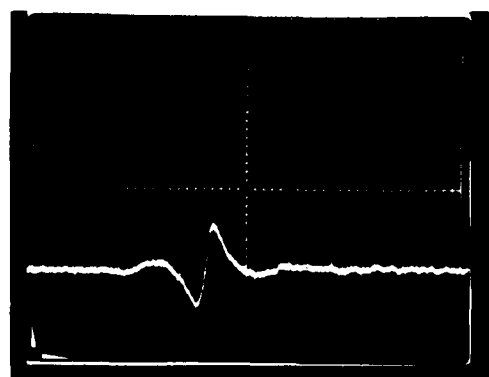
FIGURE 16. CIBLE RESULTS ON J57-#2 BEARING (S/N Y704-2RM)
OUTER RACE (S01692-5), 8296 HRS. SERVICE, VENDOR
REWORKED

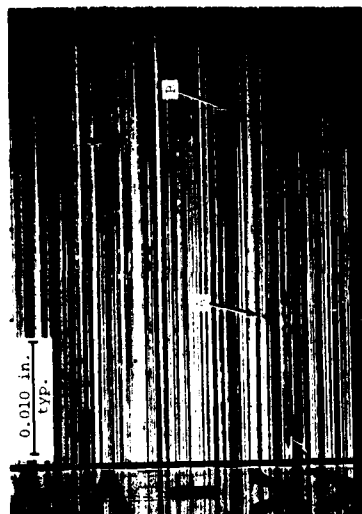
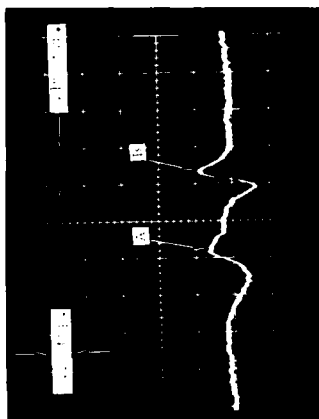
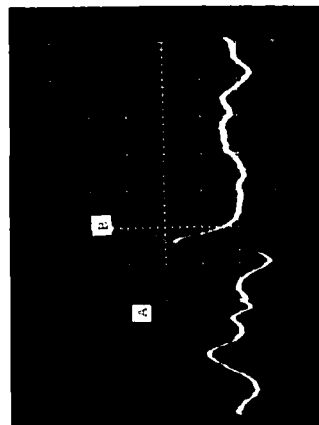
FIGURE 18. CIBL RESULTS ON J57-#2 BEARING S/N 144D-2 INNER RACE, LOADED HALF (S00762-3), 6965 HRS. SERVICE (VENDOR REWORKED) BEFORE AND AFTER ENDURANCE TESTING

Figure 23 summarizes metallurgical results in the regions of signatures A and B previously presented in Figure 18 from the inner race, loaded half of J57-#2 bearing, S/N 144D-2. Note the extensive material transformation present in the flaw region corresponding with the cracking (signature A, see Figure 18) as shown by photomicrographs B through E in Figure 23 as well as A and B of Figure 23A. It is pointed out that such extensive transformation is not evident in the flaw region corresponding with signature B (see Figure 18) as shown in photomicrographs A through D of Figure 23B.

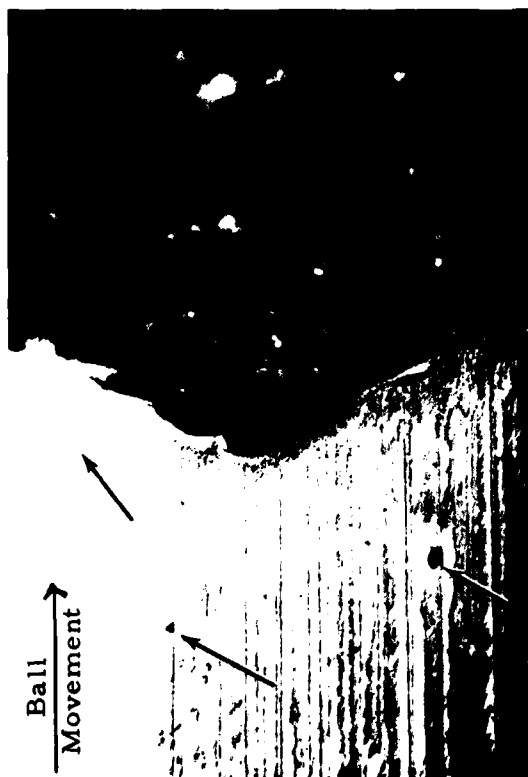
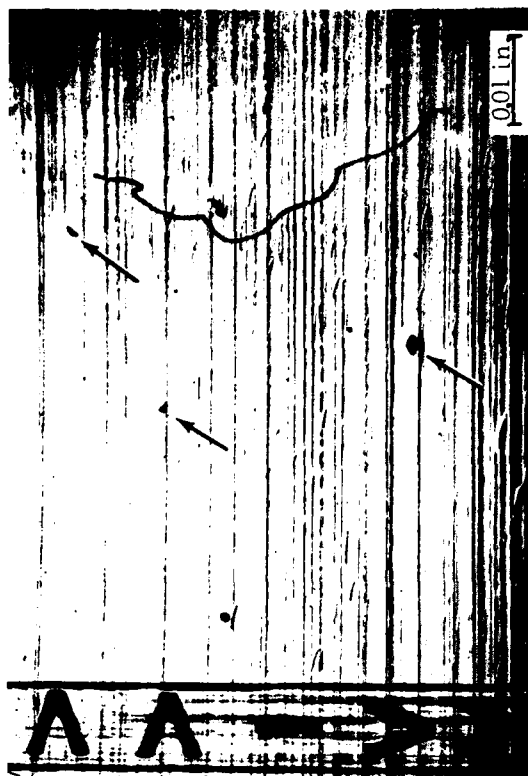
Note: Small arrows identify "landmarks" used to establish "spall front" outline in Photograph B.

FIGURE 20. VERY SMALL SPALL WHICH DEVELOPED AFTER 30 HOURS TOTAL
ENDURANCE TEST TIME, J57-#4, S/N 219A-2 (S12052-1)

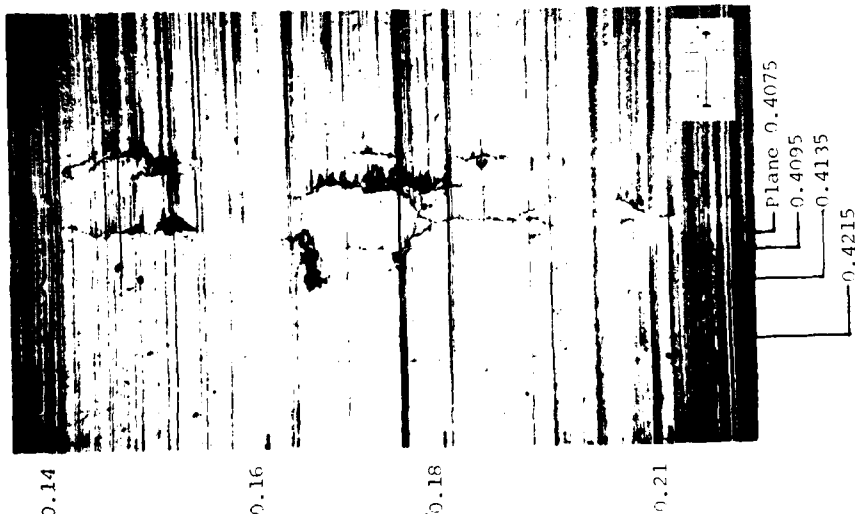
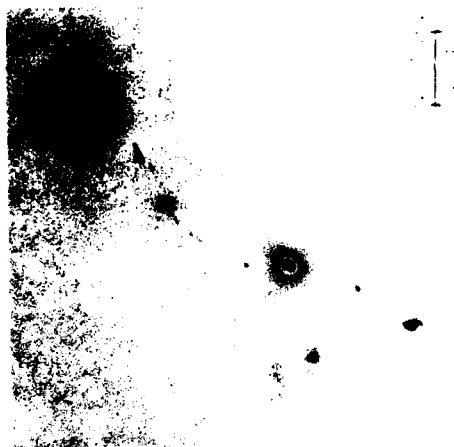
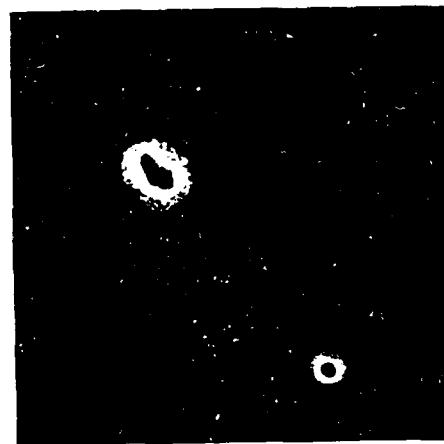
The presence of critical flaws corresponding with signatures and/or service-induced cracking have also been confirmed through metallurgical examinations. For example, Figure 22 summarizes the results of metallurgical investigations in the region of the extensive, service-induced crack network previously illustrated in Figure 8 of this report. The sectioning planes illustrated in photomicrographs B through F of Figure 22 are referenced to the sectioning plane locations indicated in photomicrograph A of the same figure. Even though the sectioning planes illustrated in Figure 22 are near one edge of the damaged region, note the significant flaws and subsurface cracking present; material transformation was also extensive in the region investigated.

FIGURE 22. METALLURGICAL EXAMINATION OF CRACK NETWORK ON J57-#2 BEARING S/N 144D-2),
INNER RACE, LOADED HALF AT BR2291 LOCATION (500762-3), (6965 SERVICE HOURS).

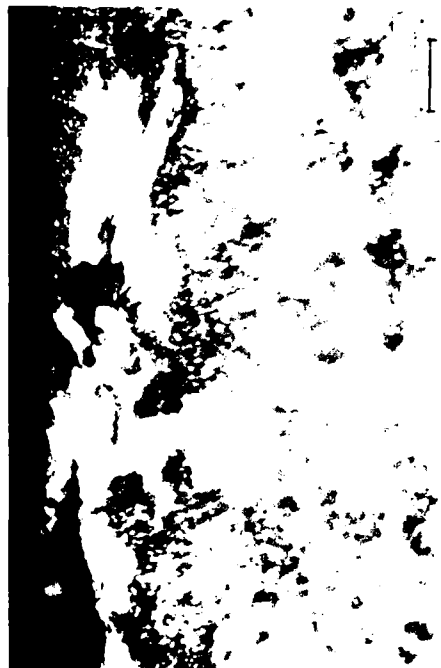
FIGURE 23. METALLURGICAL EXAMINATION OF REGIONS CORRESPONDING TO SIGNATURES A AND B ON J57-#2 BEARING (S/N 144D-2), INNER RACE LOADED HALF (S00762-3)

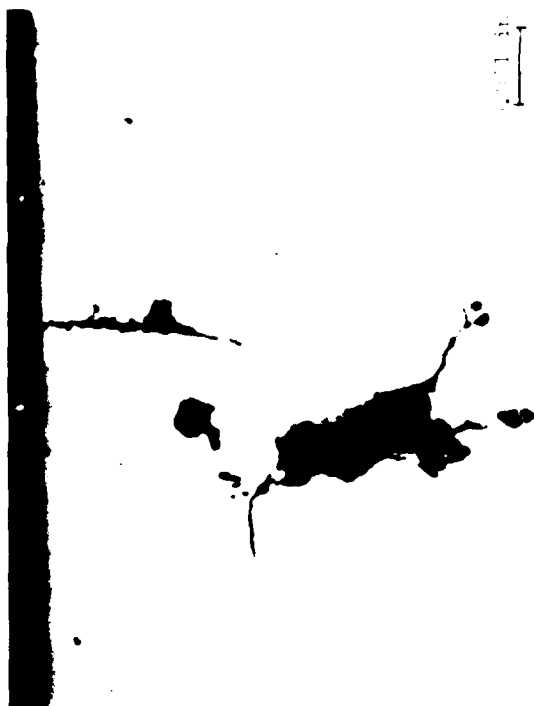
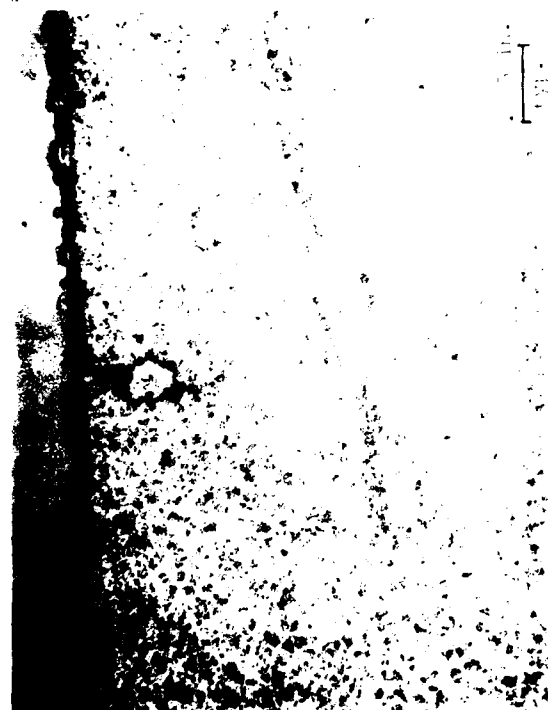
FIGURE 23B. METALLURGICAL EXAMINATION OF REGIONS CORRESPONDING TO SIGNATURES A AND B ON J57-#2 BEARING (S/N 144D-2), INNER RACE LOADED HALF (S00762-3) (continued)

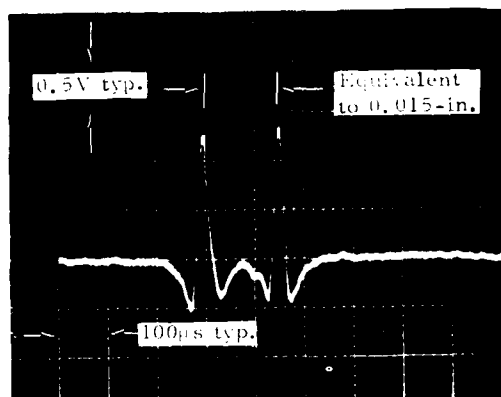
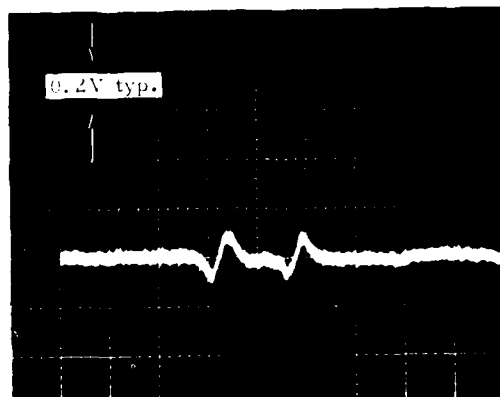
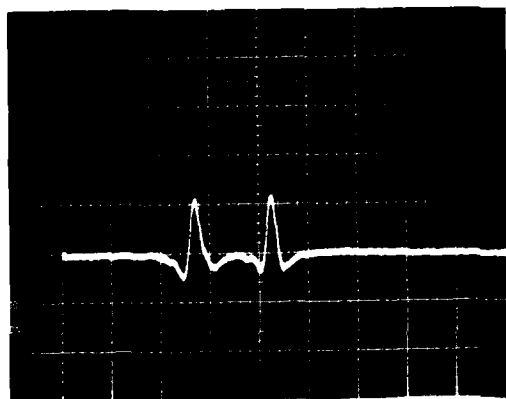
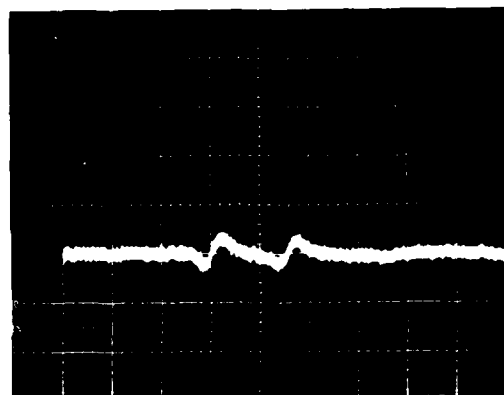
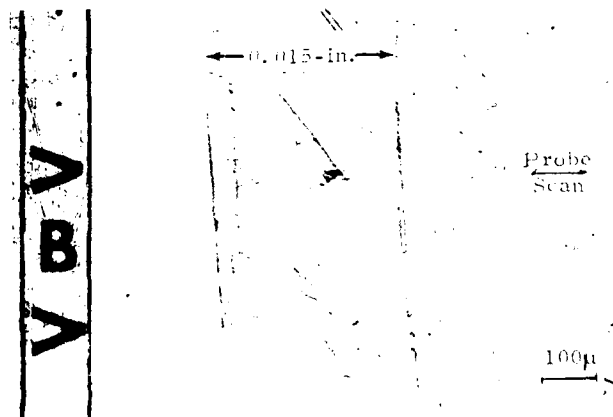
FIGURE 1. THERMAL INSPECTION SIGNATURES AND CORRESPONDING SURFACE PHOTO MICROGRAPH SHOWING GOUGES ON BALL WITH 4230 HRS SERVICE, 357-#4 BEARING S/N P9117-2 (Ball #30, Defect #3).

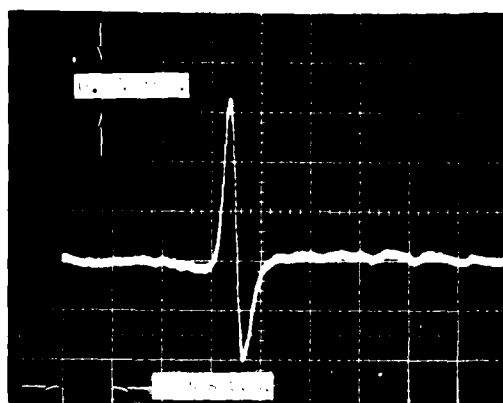
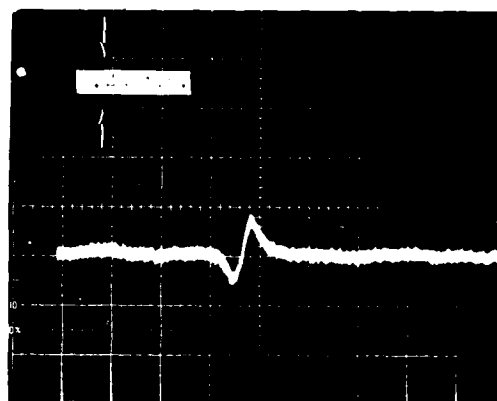
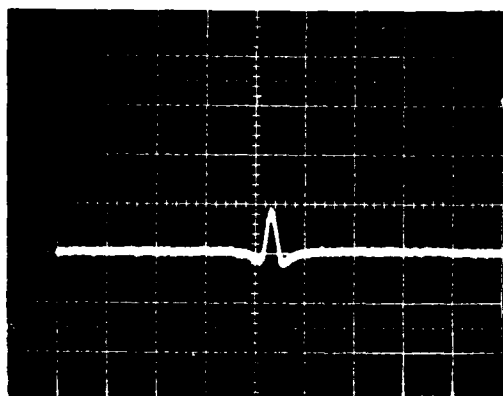
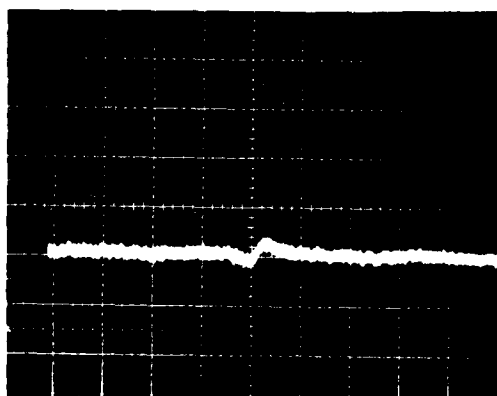
Figures 24 and 25 show the outstanding radial signatures obtained from surface damage in OCALC-processed service balls. Figures 26, 27, and 28 show an inclusion, pitting and cracks and a substantial crack network with loss of material, respectively, from vendor processed bearings, apparently new balls. While the data presented above for balls is not from sampling a large part of the overall ball population, it does clearly show the extent of flaw conditions present in balls from serviceable bearings. Many other examples of signatures and corresponding flaws are presented in Appendix C.

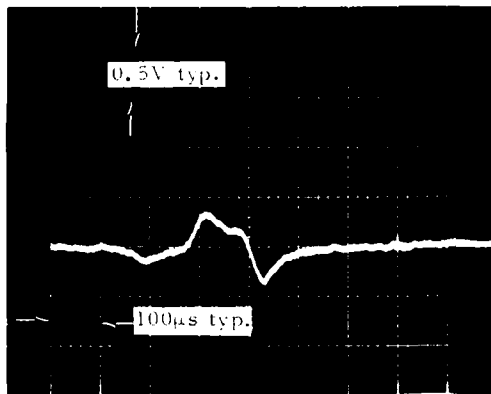
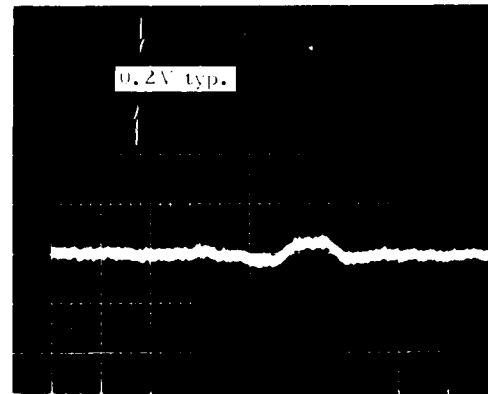
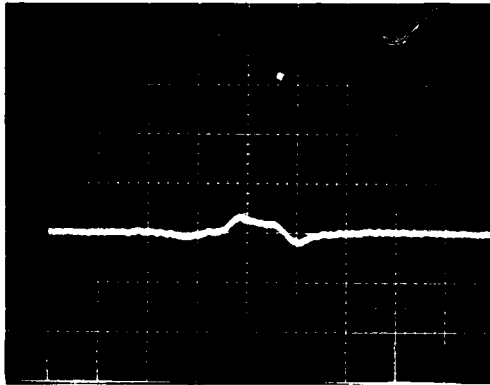
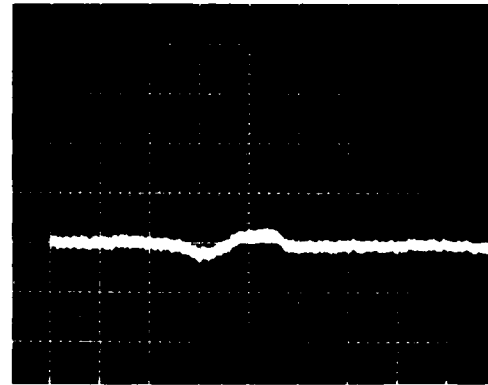
Reproductions of signatures and surface photomicrographs typical of the inspection results obtained are presented in this section. Figure 1 presents typical magnetic perturbation, radial and circumferential, high and low field (RH, RL, CH, CL) signatures from a broad, shallow indent on a service ball (3,230 hours service). The outline of one edge of the long, broad, shallow indent is pointed out by the arrow in the surface photomicrograph E at the bottom of Figure 1. It is also pointed out that the general surface, fine-scale features shown in the photomicrograph are typical of the surface observed for service balls. Figure 2 shows an indentation in another service ball from the same bearing (S/N P9117-1). Note in this case that the radial signatures are significantly greater in amplitude and the circumferential signatures slightly greater in amplitude than that for the indent in Ball #3 (see Figure 1), indicating the indentation in Ball #9 (Figure 2) to be of greater depth. The radial signatures and corresponding photomicrographs in Figure 3 show typical results from a corrosion region and also from a large pit; accompanying circumferential signatures are low amplitude indicating the flaws to be shallow, probably less than 0.001 inch deep. The photomicrograph in Figure 4 illustrates gouges which may also be introduced as a result of service. In the case of Figure 4, note that the distance between the two gouges corresponds to the

FIGURE 1. CIBLE INSPECTION SIGNATURES AND CORRESPONDING SURFACE PHOTOMICROGRAPH SHOWING INDENT ON BALL WITH 3230 HRS SERVICE, J57-#4 BEARING S/N P9117-1 (Ball #3).

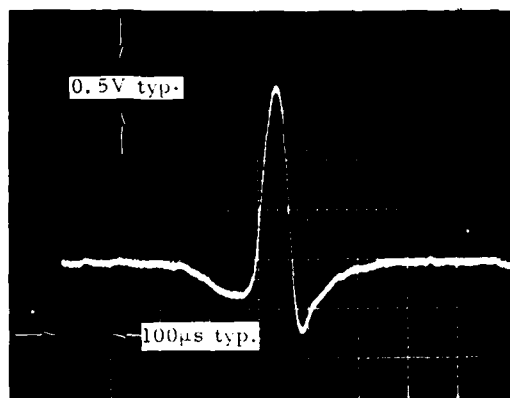
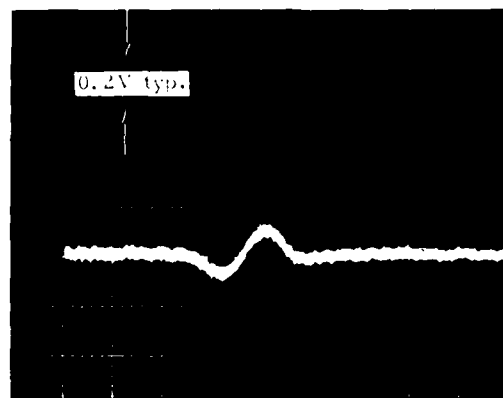
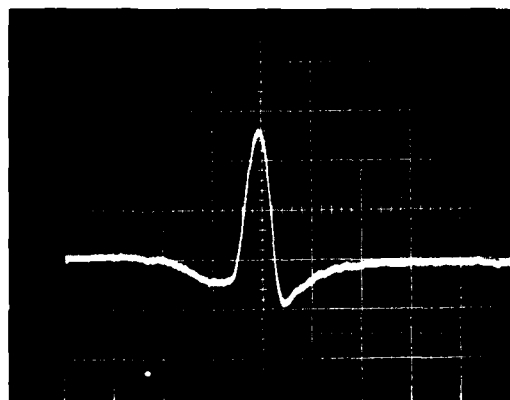
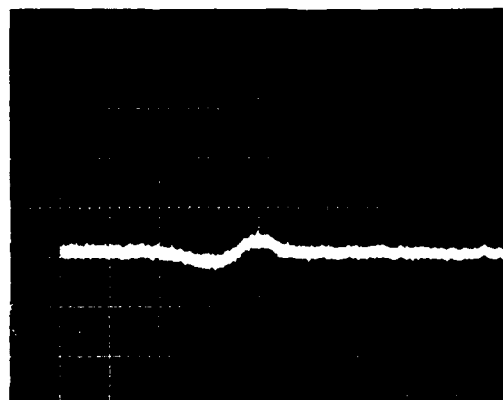
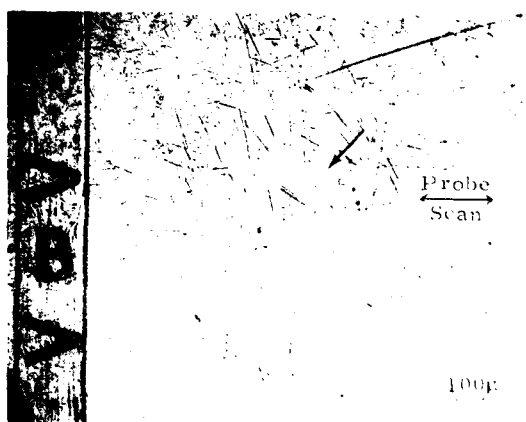
FIGURE 2. CIBLE INSPECTION SIGNATURES AND CORRESPONDING SURFACE PHOTOMICROGRAPH SHOWING DENT ON BALL WITH 3230 HRS SERVICE, J57-#4 BEARING S/N P9117-1 (Ball #9).

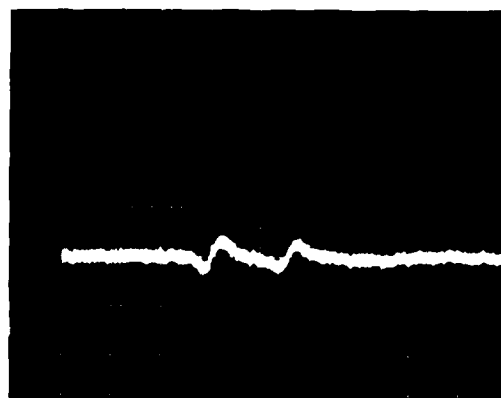
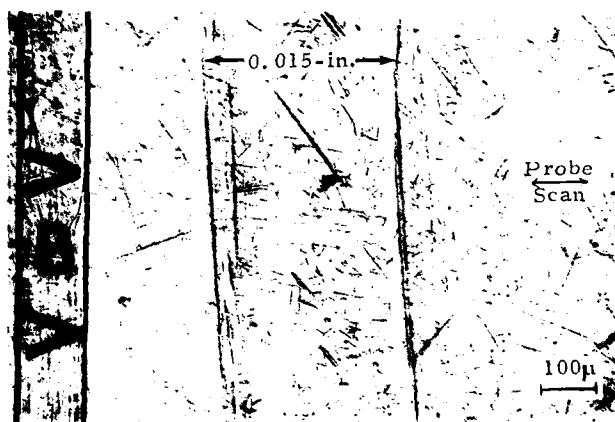
separation between the resulting radial signatures. These gouges have sufficient depth to produce small, circumferential signatures also (see Records C and D in Figure 4). Figure 5 shows pit and gouge type defects in two other service balls. Again, note the large radial signatures; the small circumferential, high field (CH) signature in the case of the gouge indicates that this flaw does not have significant depth.

FIGURE 4. CIBLE INSPECTION SIGNATURES AND CORRESPONDING SURFACE PHOTOMICROGRAPH SHOWING GOUGES ON BALL WITH 3230 HRS SERVICE, J57-#4 BEARING S/N P9117-2 (Ball #20, Defect #3).

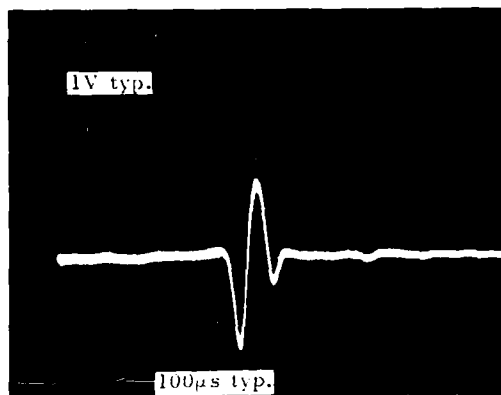
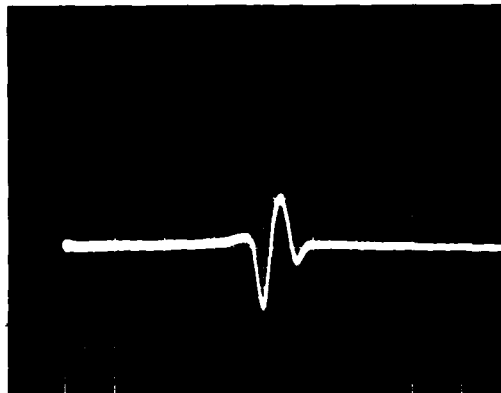
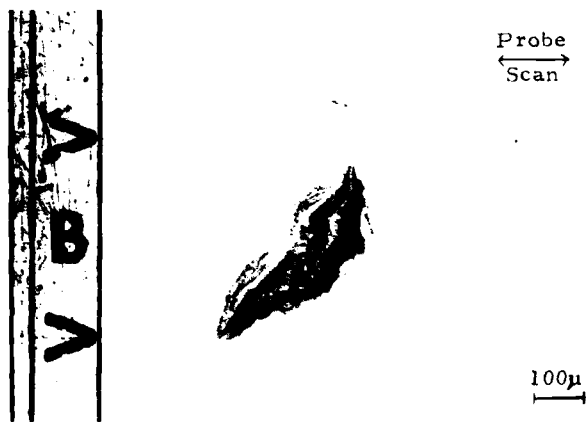
Figure 6 illustrates the magnetic response obtained from a surface inclusion pit (see surface photomicrograph E). The surface finish surrounding the pit in Figure 6 is typical of that observed for the new balls examined from reworked bearings. A comparison of the surface finish in Figure 6 with that for the service ball in Figure 1 indicates that the multitude of fine, short and long scratch lines are typical of balls with service. The data in Figure 7 shows evidence of another inclusion pit with significant depth since a relatively large circumferential high field signature is obtained (see record C). Similarly, the data in Figure 8 shows a large group of pits from which two outstanding radial signatures are obtained; the smaller circumferential signature indicates these pits to be shallower in depth than the one previously shown in Figure 7. A significant group of pits in still another new ball is illustrated in Figure 9. Gouges in new balls are also evident as illustrated in Figures 10 and 11; very large radial signatures are evident in both cases.

FIGURE 10. CIBLE INSPECTION SIGNATURES AND CORRESPONDING SURFACE PHOTOMICROGRAPH SHOWING ANOMALY ON NEW BALL FROM VENDOR REWORKED J57-#4 BEARING S/N 9191-1, 1500 HRS (Ball #4, S11911).

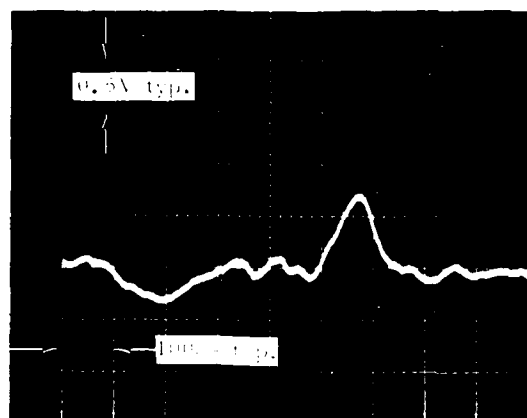
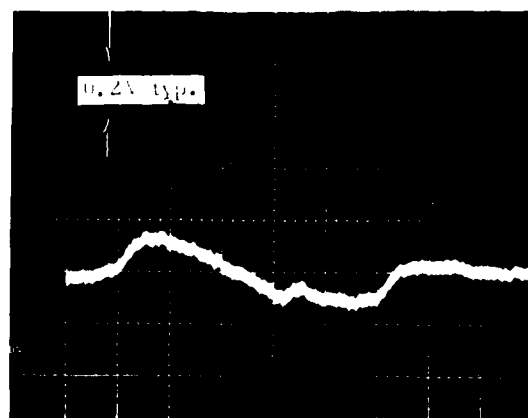
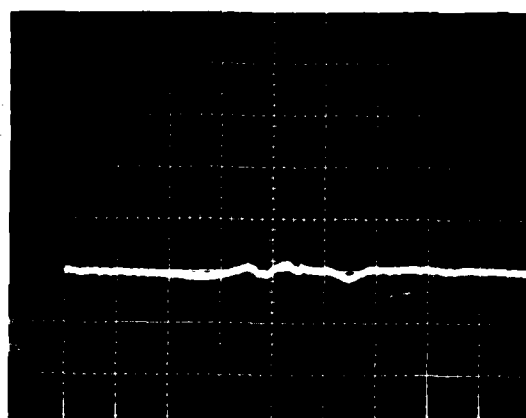
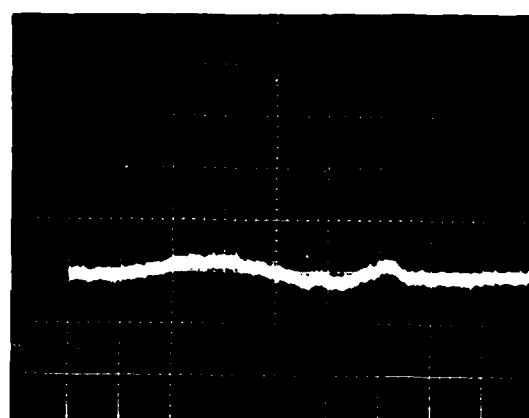
As might be anticipated, essentially no evidence of indentations were observed in the new balls visually examined. Startling evidence, however, was obtained showing large-scale cracking and material loss in two new balls from one bearing (S/N395-2) as illustrated in Figures 12 and 13. The radial and circumferential signatures presented in Figure 12 are typical of those previously described as unusual, "poor shape" signatures (note the broad, opposite polarity of the CH signature and the broad, complex-shaped RH signature with a small amplitude RL signature). Examination of many regions corresponding to "poor shape" signatures did not yield visual evidence at the surface of flaw conditions similar to that illustrated in the photomicrographs at the bottom of Figure 12. Note the even more significant material loss and extensive cracking evident in case of the flaw illustrated in Figure 13 and corresponding magnetic perturbation response (typical of that obtained from inclusions and gouges); the complex CH signature shape is attributed to the complex nature of the flaw. It is anticipated that the flaw illustrated in Figure 13 resulted from the heat treating process, possibly in combination with an extended inclusion(s). As will be shown next in this section, the Barkhausen signatures from this ball (Ball #3 in Bearing S/N 395-2) also exhibited unusual Barkhausen signatures.

FIGURE 12. CIBLE INSPECTION SIGNATURES AND CORRESPONDING SURFACE PHOTOMICROGRAPHS SHOWING PITS AND CRACKS ON NEW BALL FROM VENDOR REWORKED J57-#4 BEARING S/N 395-2, 4362 HRS (Ball #11, S11672).

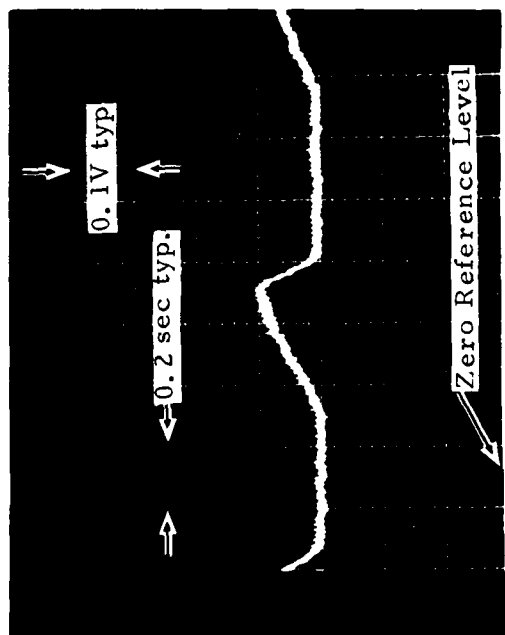
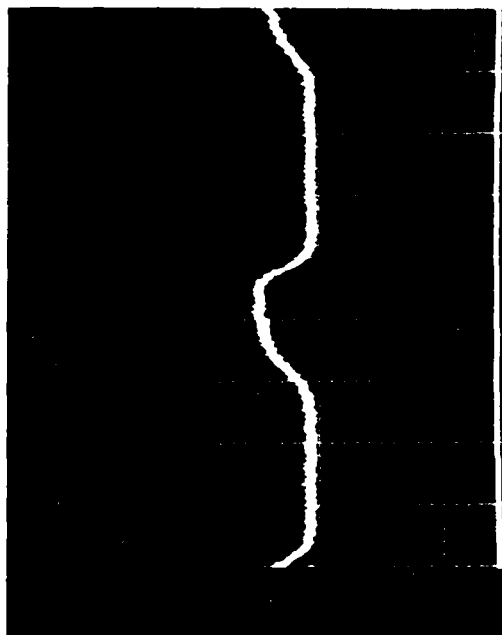
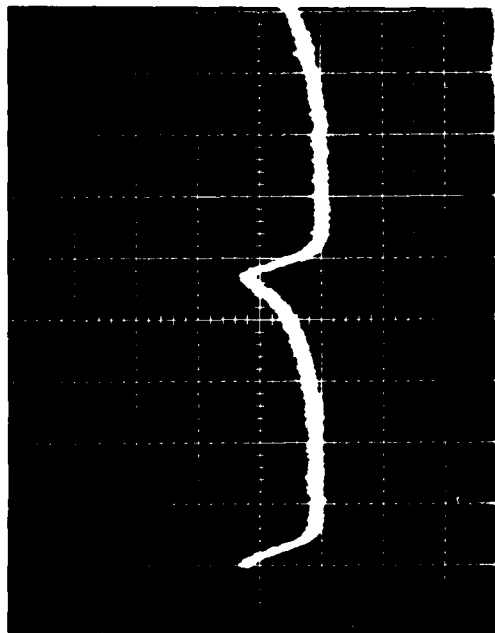
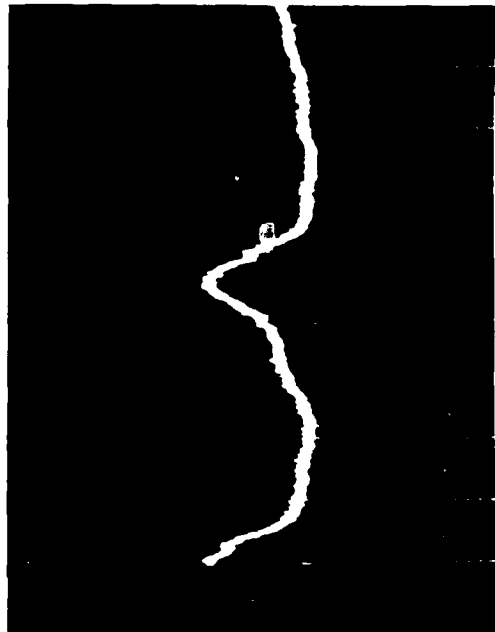
Typical Barkhausen signature shapes obtained from service and new balls are illustrated in Figure 14. The Barkhausen signatures illustrated in Records C and D of Figure 14 are typical of those observed from service balls. The signatures illustrated in Records A and B of Figure 14 are dominantly typical for new balls, although, signatures Type C and D were also observed in the case of the new balls. Significantly, Figure 15 illustrates the Barkhausen signatures obtained from four new balls on Bearing S/N 395-2. Note the leading edge signature feature, as pointed out by the arrow in each case, which is not evident in any of the Barkhausen signatures previously illustrated in Figure 14. Furthermore, the signature shown in Record A of Figure 15 was obtained from the ball containing the extensive crack network, see Figure 13. From the data presented in Figures 12, 13, and 15 the entire ball complement for Bearing S/N 395-2 is questionable (in addition, the ball complement in the mating duplex Bearing S/N 395-1 is also suspect). It is possible that many other balls from the same lot of balls containing those in Bearing S/N 395-2 are also suspect, however, SwRI does not have adequate information for this type of traceability.

FIGURE 14. TYPICAL BARKHAUSEN SIGNATURES FROM J57-#4 MAIN SHAFT BEARING BALLS.

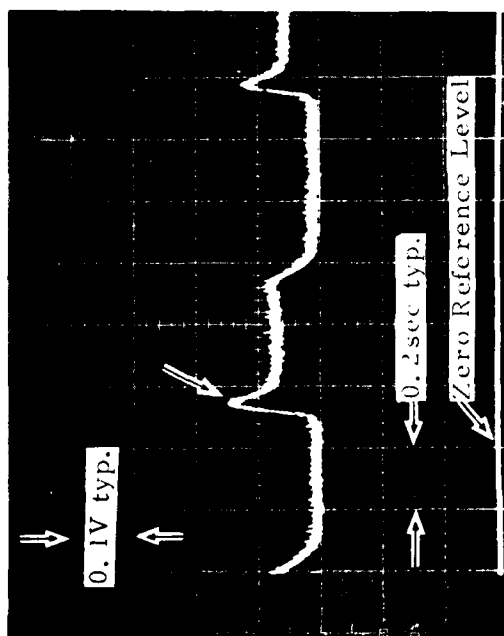
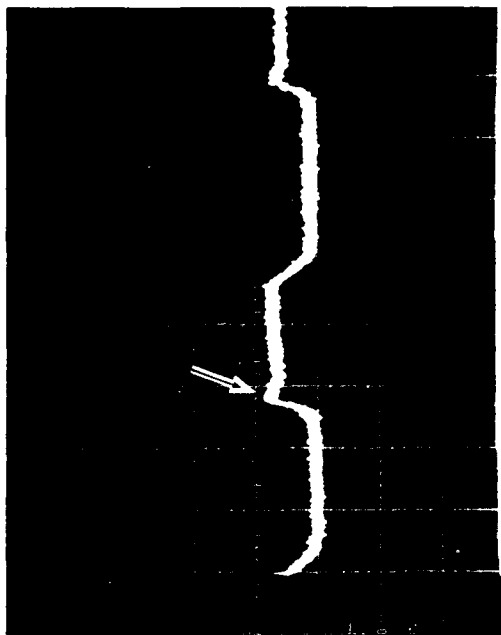
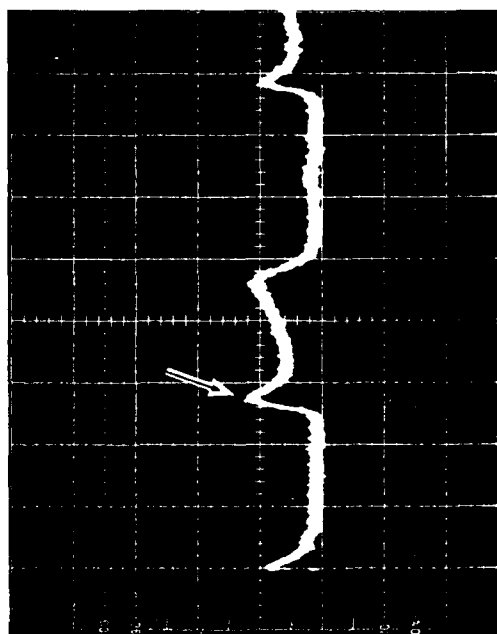
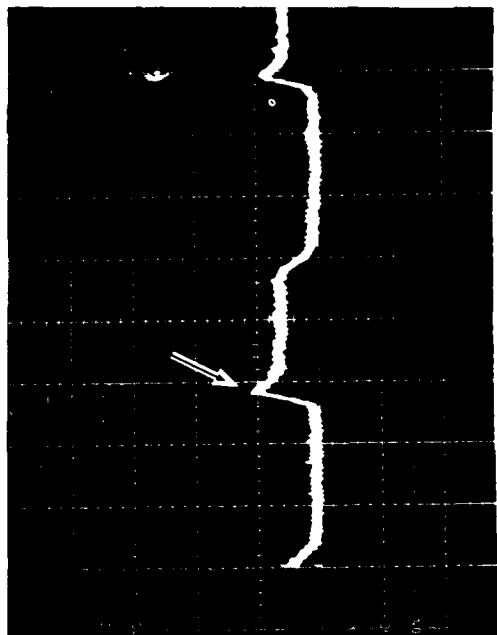
FIGURE 15. BARKHAUSEN SIGNATURES FOR FOUR BALLS FROM J57-#4 VENDOR REWORKED BEARING
S/N 395-2 (S11672), 4362 HRS.

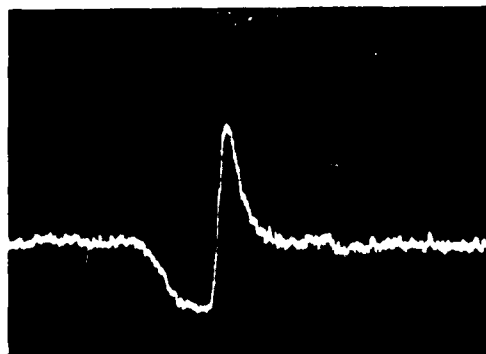
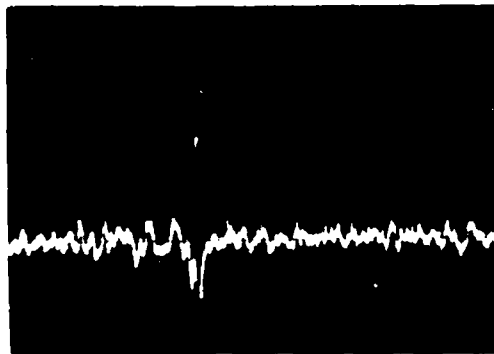
| Test Results | Prior Signature | Test Data Hrs - Stress | Bearing Type | Remarks | AF S/N (SwRI No.) | Test Ref. No. |
|---|---|---|---|---|---|---|
| Spall | CH, 0005-4853 microcracking | 499.2-204 ksi 4.9-332 ksi | J57-#2 | Inner race, LH; 2053 hrs. service | B1274-2 (S00032) | 6, 11, 13 |

Magnified (100X) View of Surface Showing the
Flaw that Caused the CH and RH Signatures

FIGURE F2. CIBLE RESULTS ON J57-#2 BEARING (S/N B1274-2) INNER RACE
 (Reworked bearing accepted by Air Force and considered
 equivalent to new bearing.)

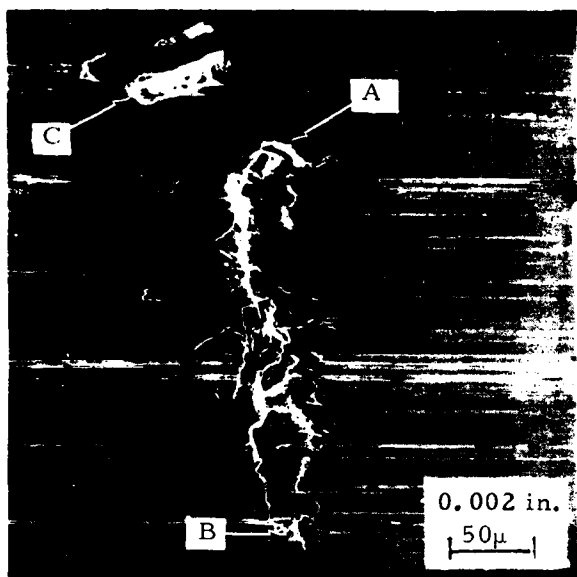
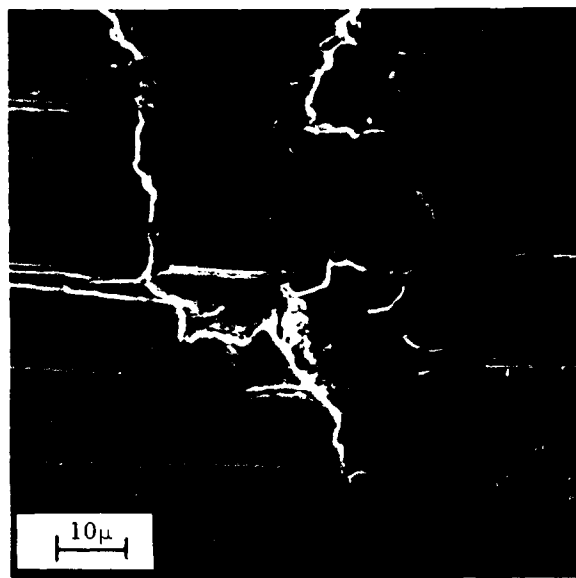
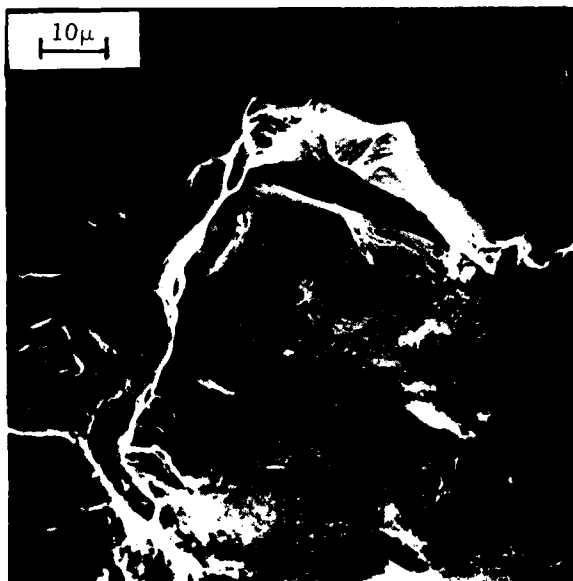
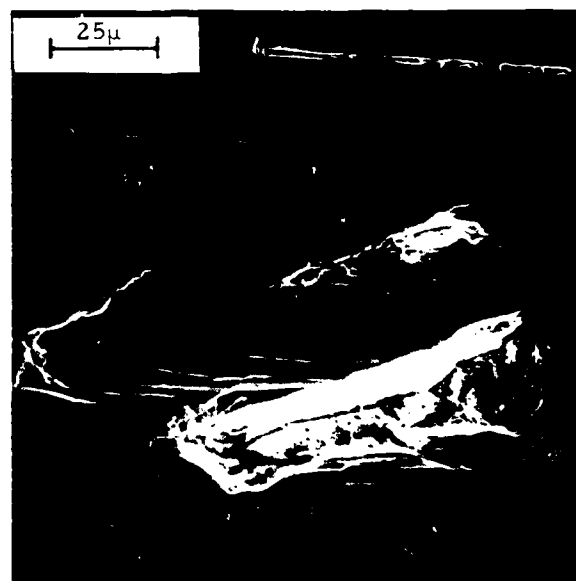
FIGURE F3. SCANNING ELECTRON MICROSCOPE (SEM) PHOTOGRAPHS OF SURFACE IMPERFECTION (Replica) AT 0004-4851, J57-#2 BEARING (S/N B1274-2) INNER RACE (Reworked Bearing).

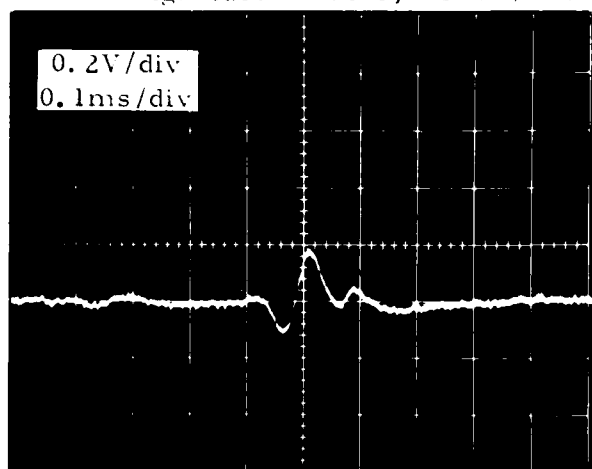
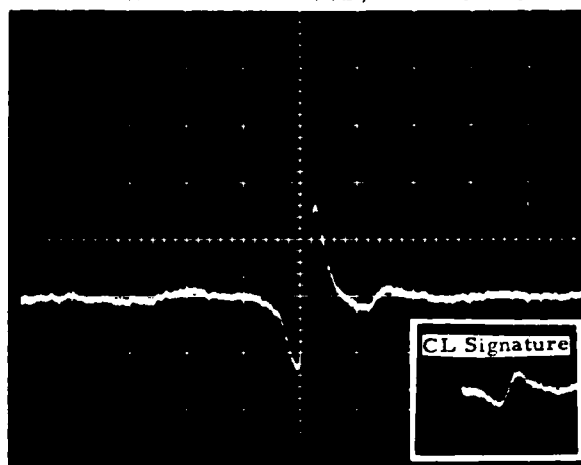
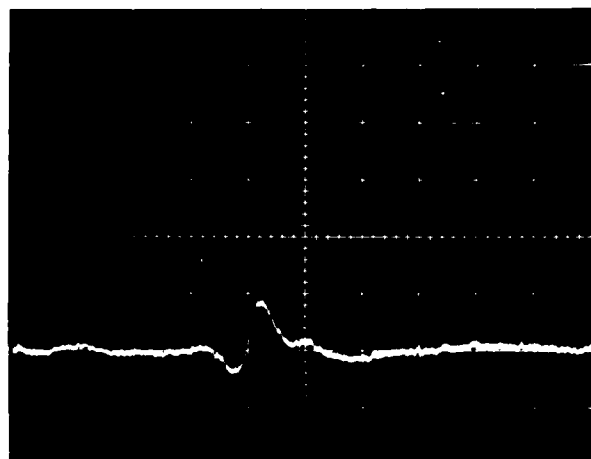
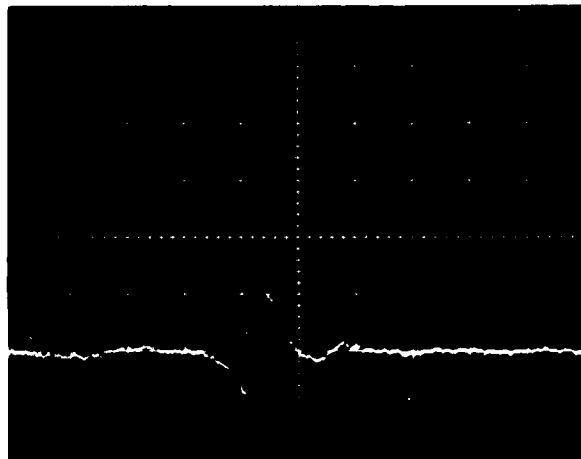
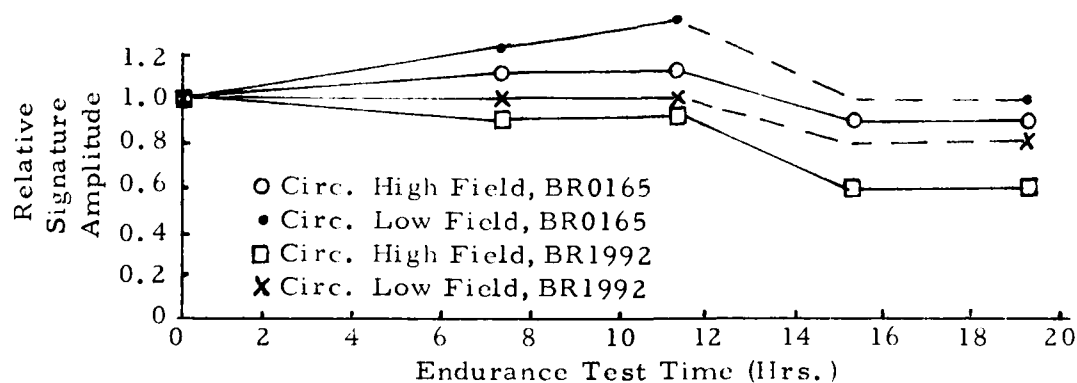
| Test Results | Prior Signature | Test Data Hrs - Stress | Bearing Type | Remarks | AF S/N (SwRI No.) | Test Ref. No. |
|---|---|---|---|---|---|---|
| Spall | CH, 0009-0165 | 26.2-332 ksi | J57-#4 | Inner race, NLH; 5678 hrs. service | 748A-1 (S10981) | 3 |

FIGURE F6. MAGNETIC PERTURBATION CIRCUMFERENTIAL FLUX SIGNATURES AT FLAW LOCATIONS 0009-0165 AND 0010-1992 AS A FUNCTION OF ENDURANCE TEST TIME, J57-#4 BEARING S/N 748A-1, INNER RACE S10981(1).
